Agenda

Regular Meeting of Council
Corporation of the Township of The North Shore
Wednesday, March 20th, 2024
6:00 PM

RECOMMENDATION: That Council receive the staff report as presented regarding the Geotechnical Report for Riverview Road from TULLOCH, and that Council approve the proposed Option 3 for pavement design.

This report outlines the results of the geotechnical investigation and provides geotechnical design recommendations and construction considerations for the proposed rehabilitation of the paved road section.

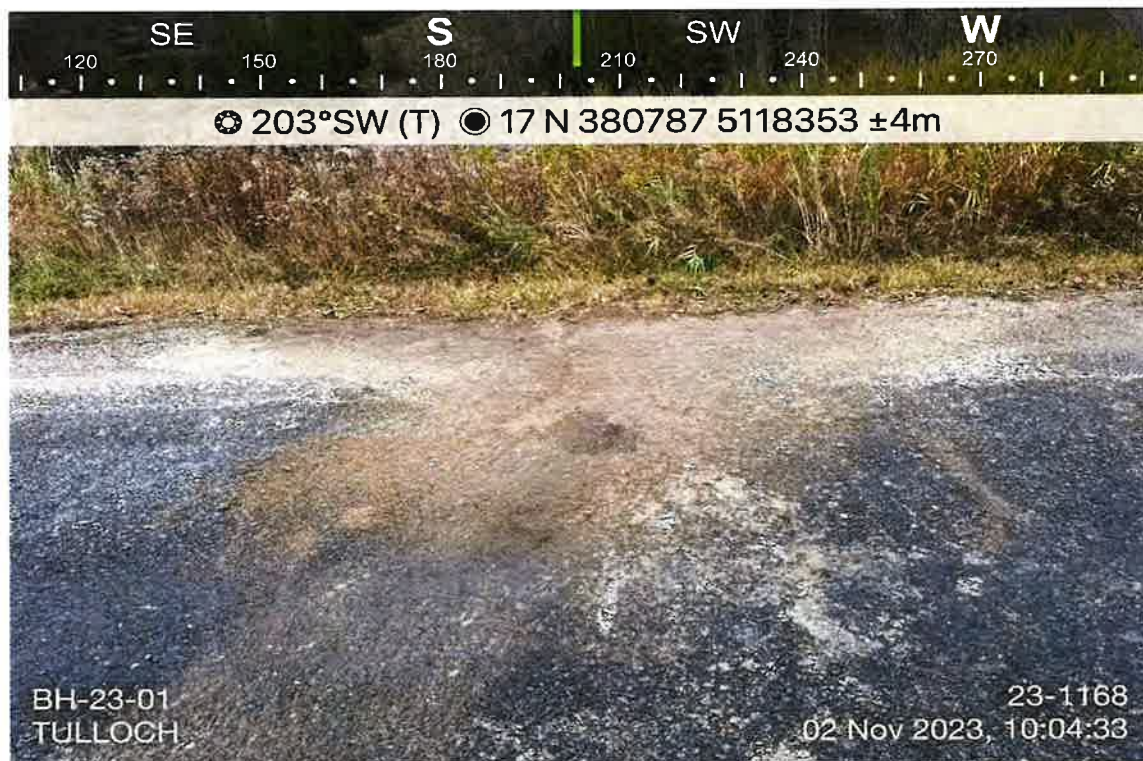
Photo 2: BH-23-01 following completion of backfill. Photo taken facing southwest.
